Engineering Report 40881-4

Water Intrusion (Immersion) Test

**Mechatronics, Inc.
8152 - 304th Avenue S.E.
Preston, WA 98050**

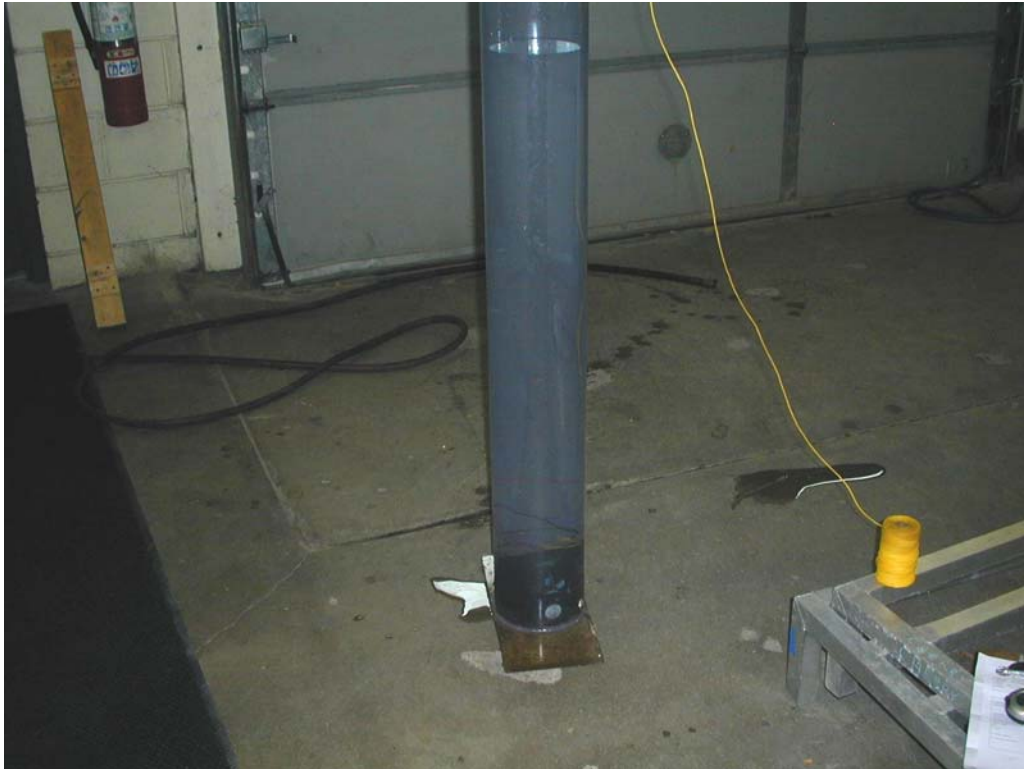
Photograph 1: Test unit under test

Figure 1, herein, is the test data sheet. Photographs 1 and 2 show test units under test. Photographs 3 through 5 show test unit identification.

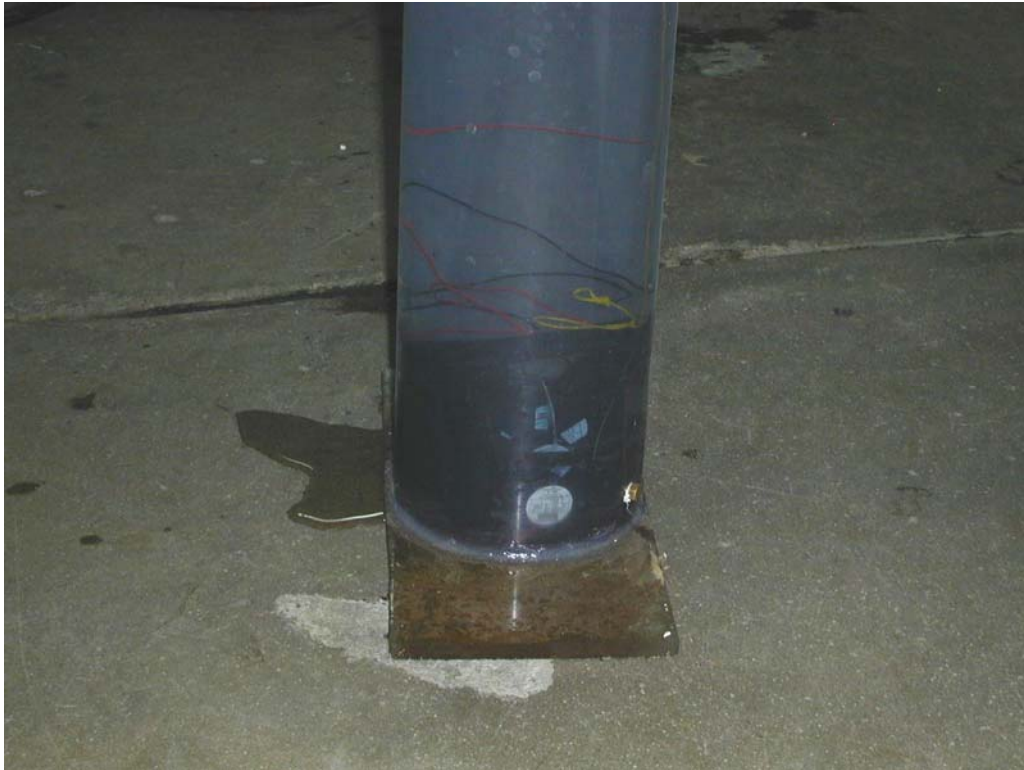
Photograph 2: Test unit under test

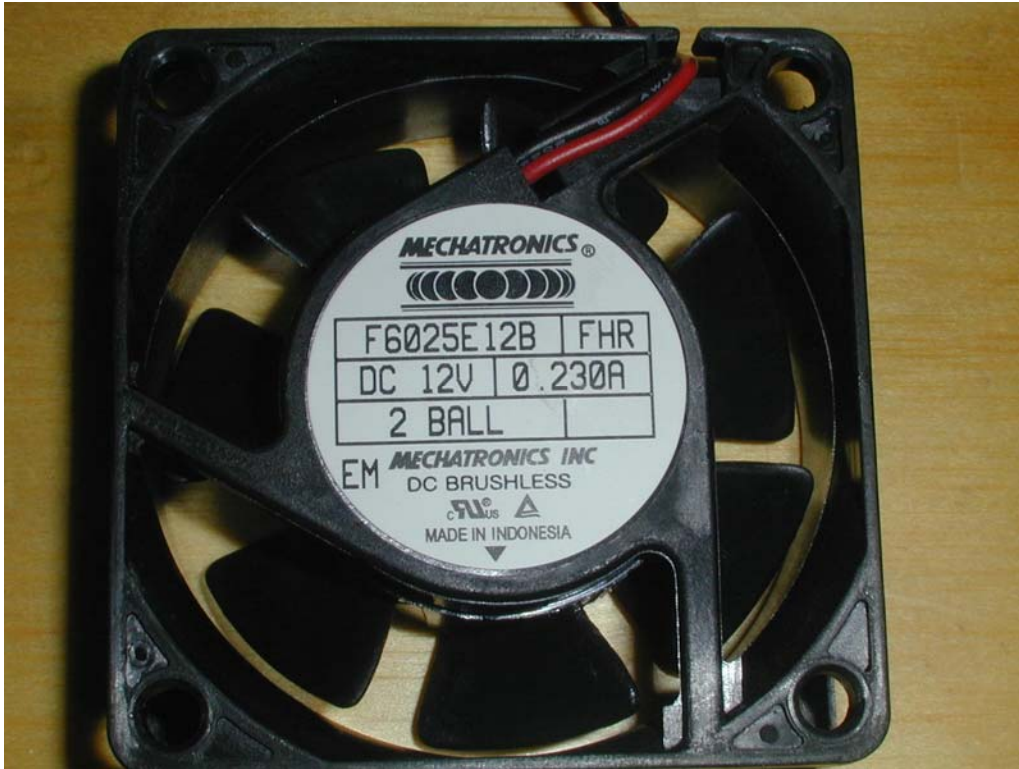
Photograph 3: Test unit identification

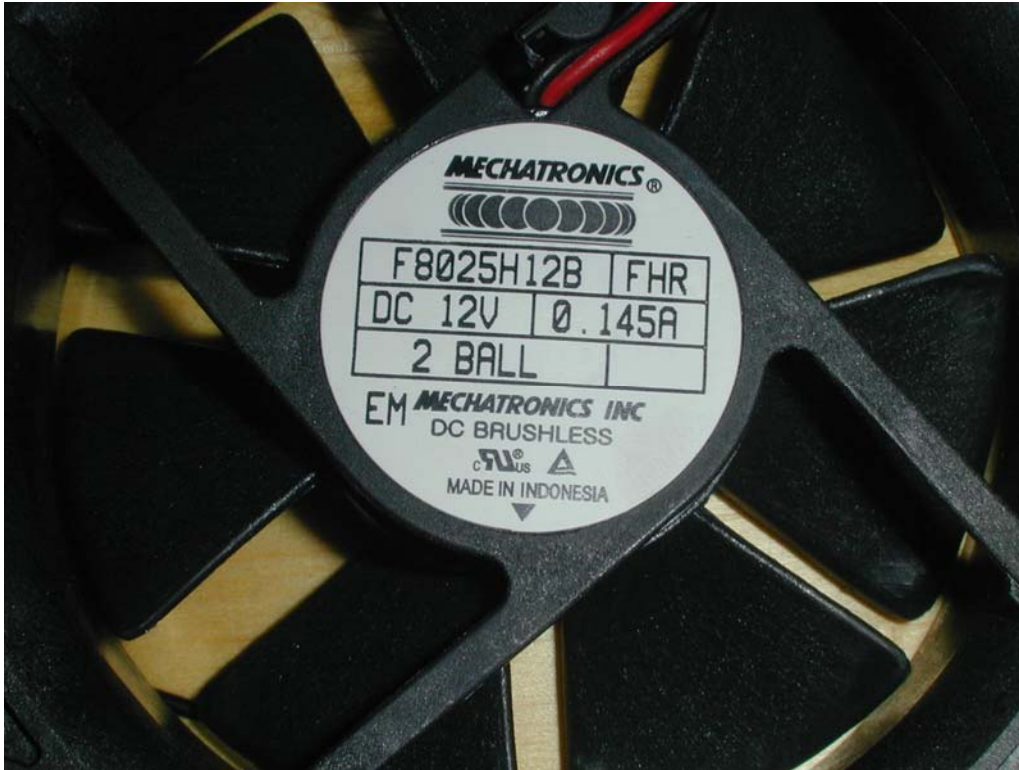
Photograph 4: Test unit identification

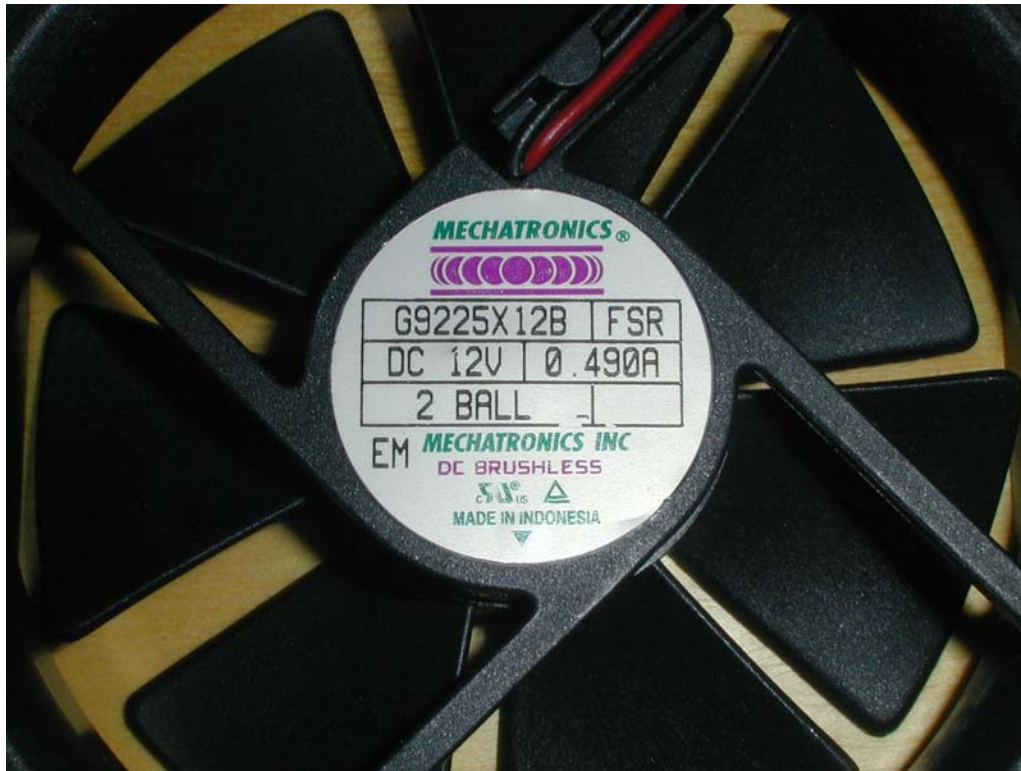
Photograph 5: Test unit identification
